**BROOKVILLE LAKE
GREATER MIAMI RIVER BASIN
INDIANA**

**EMBANKMENT CRITERIA AND
PERFORMANCE REPORT**

**PREPARED BY
U.S. ARMY ENGINEER DISTRICT, LOUISVILLE
CORPS OF ENGINEERS**

SEPTEMBER 1982

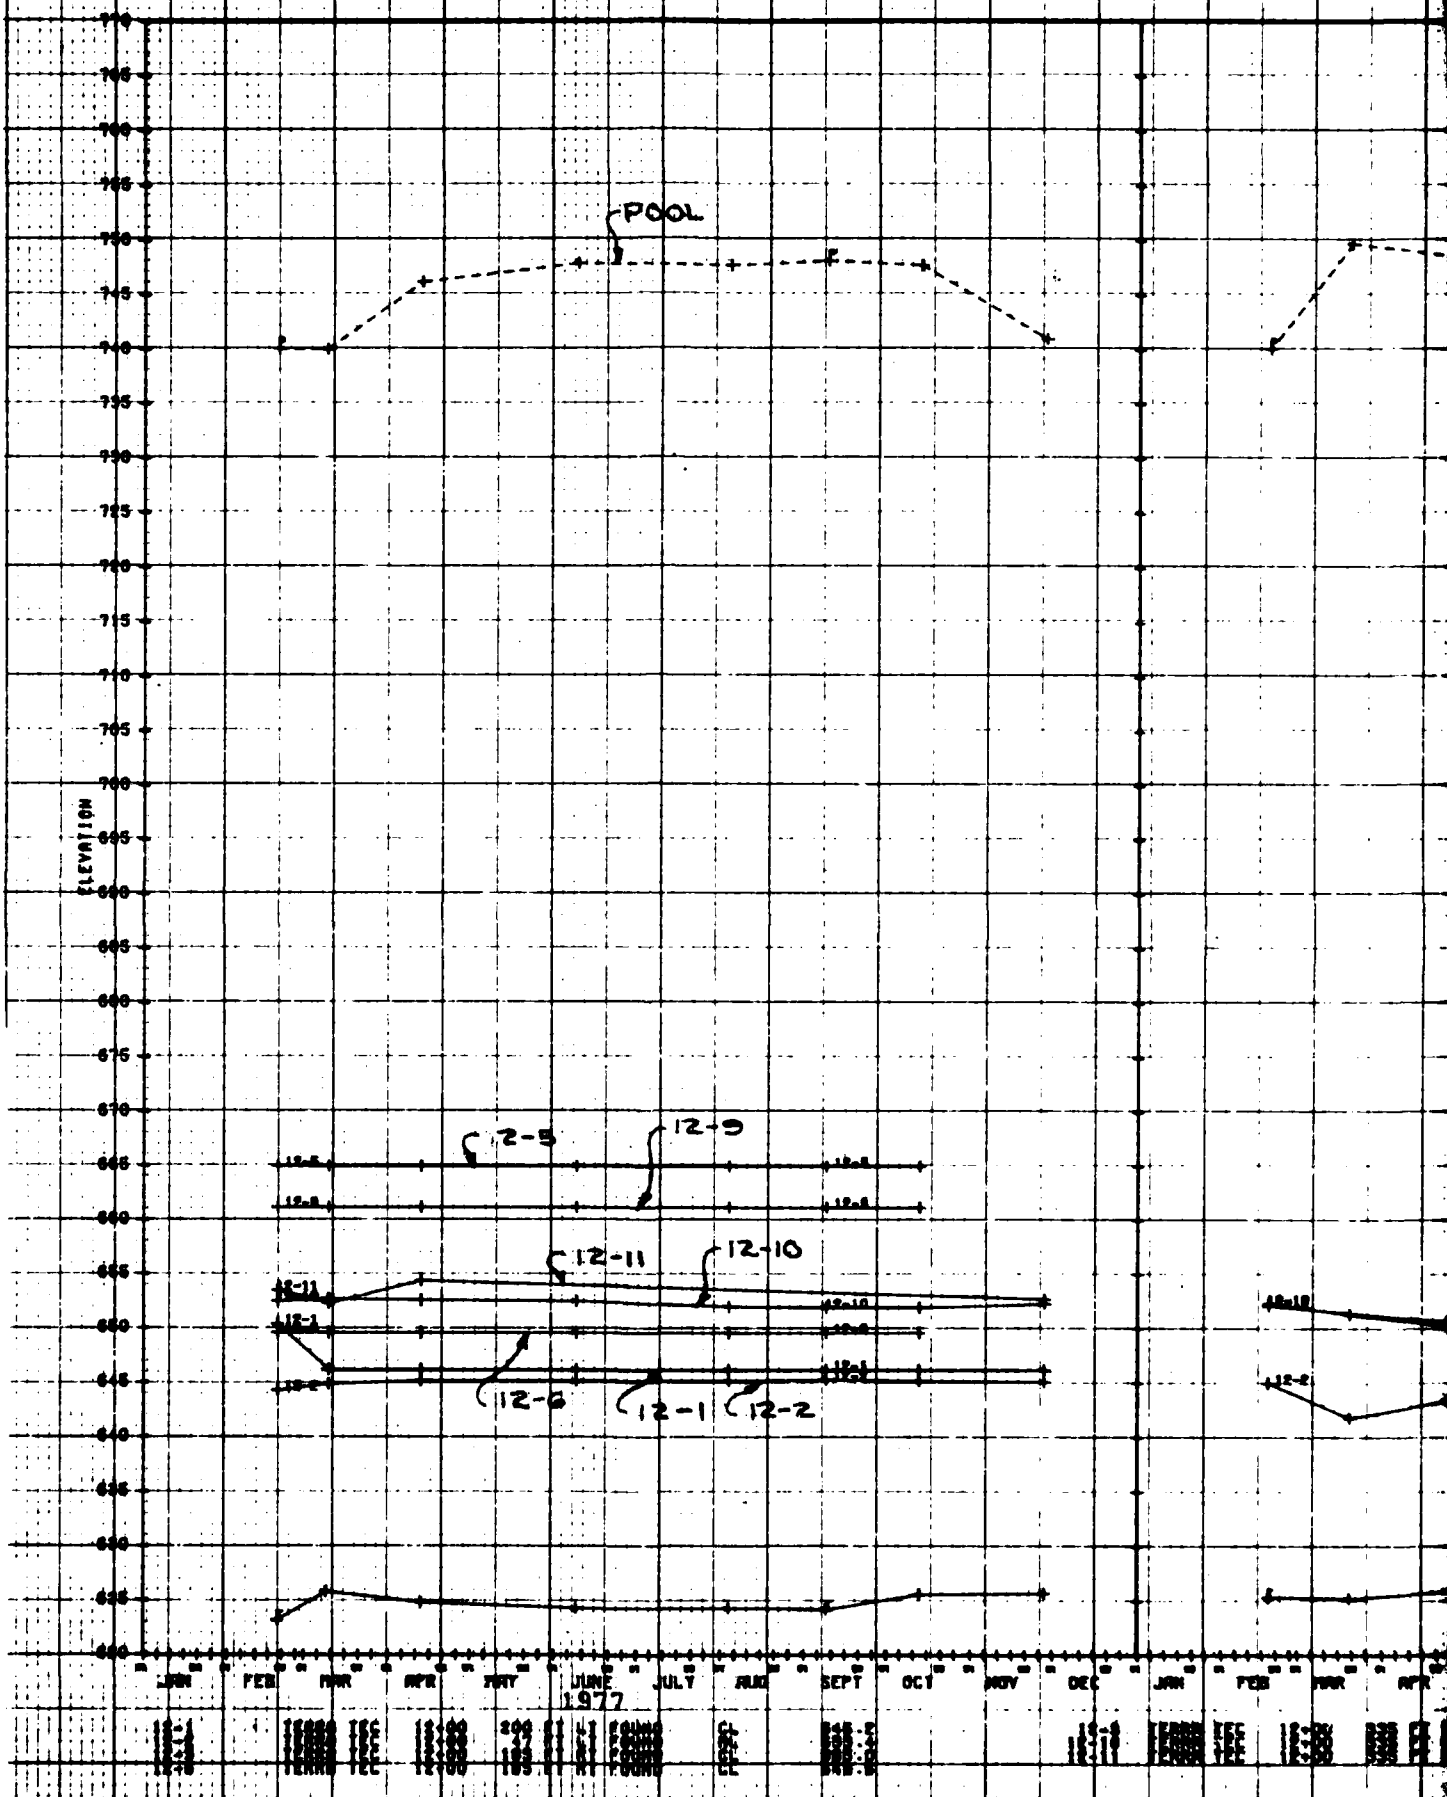
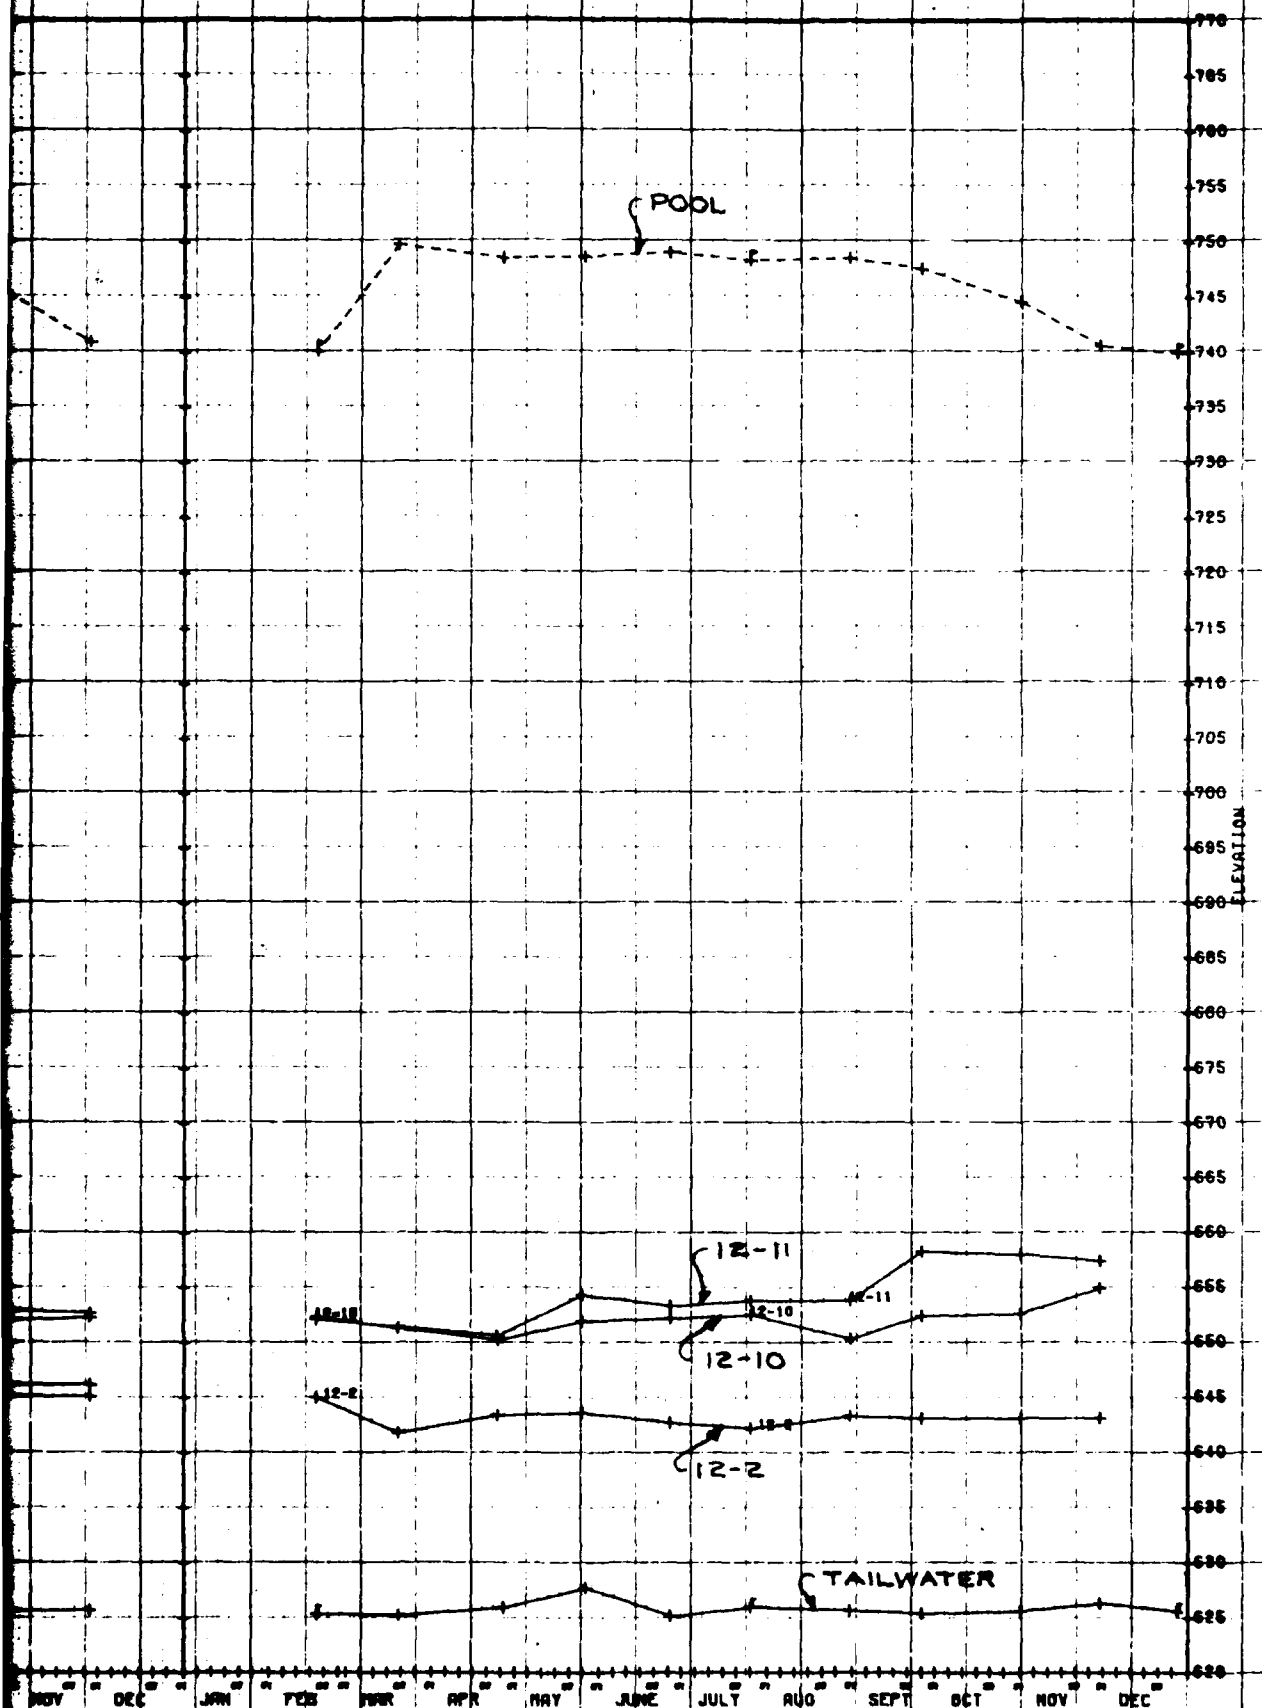
FOUNDATION PIEZOMETERS STA. 12+00

12-11 12-10 12-2

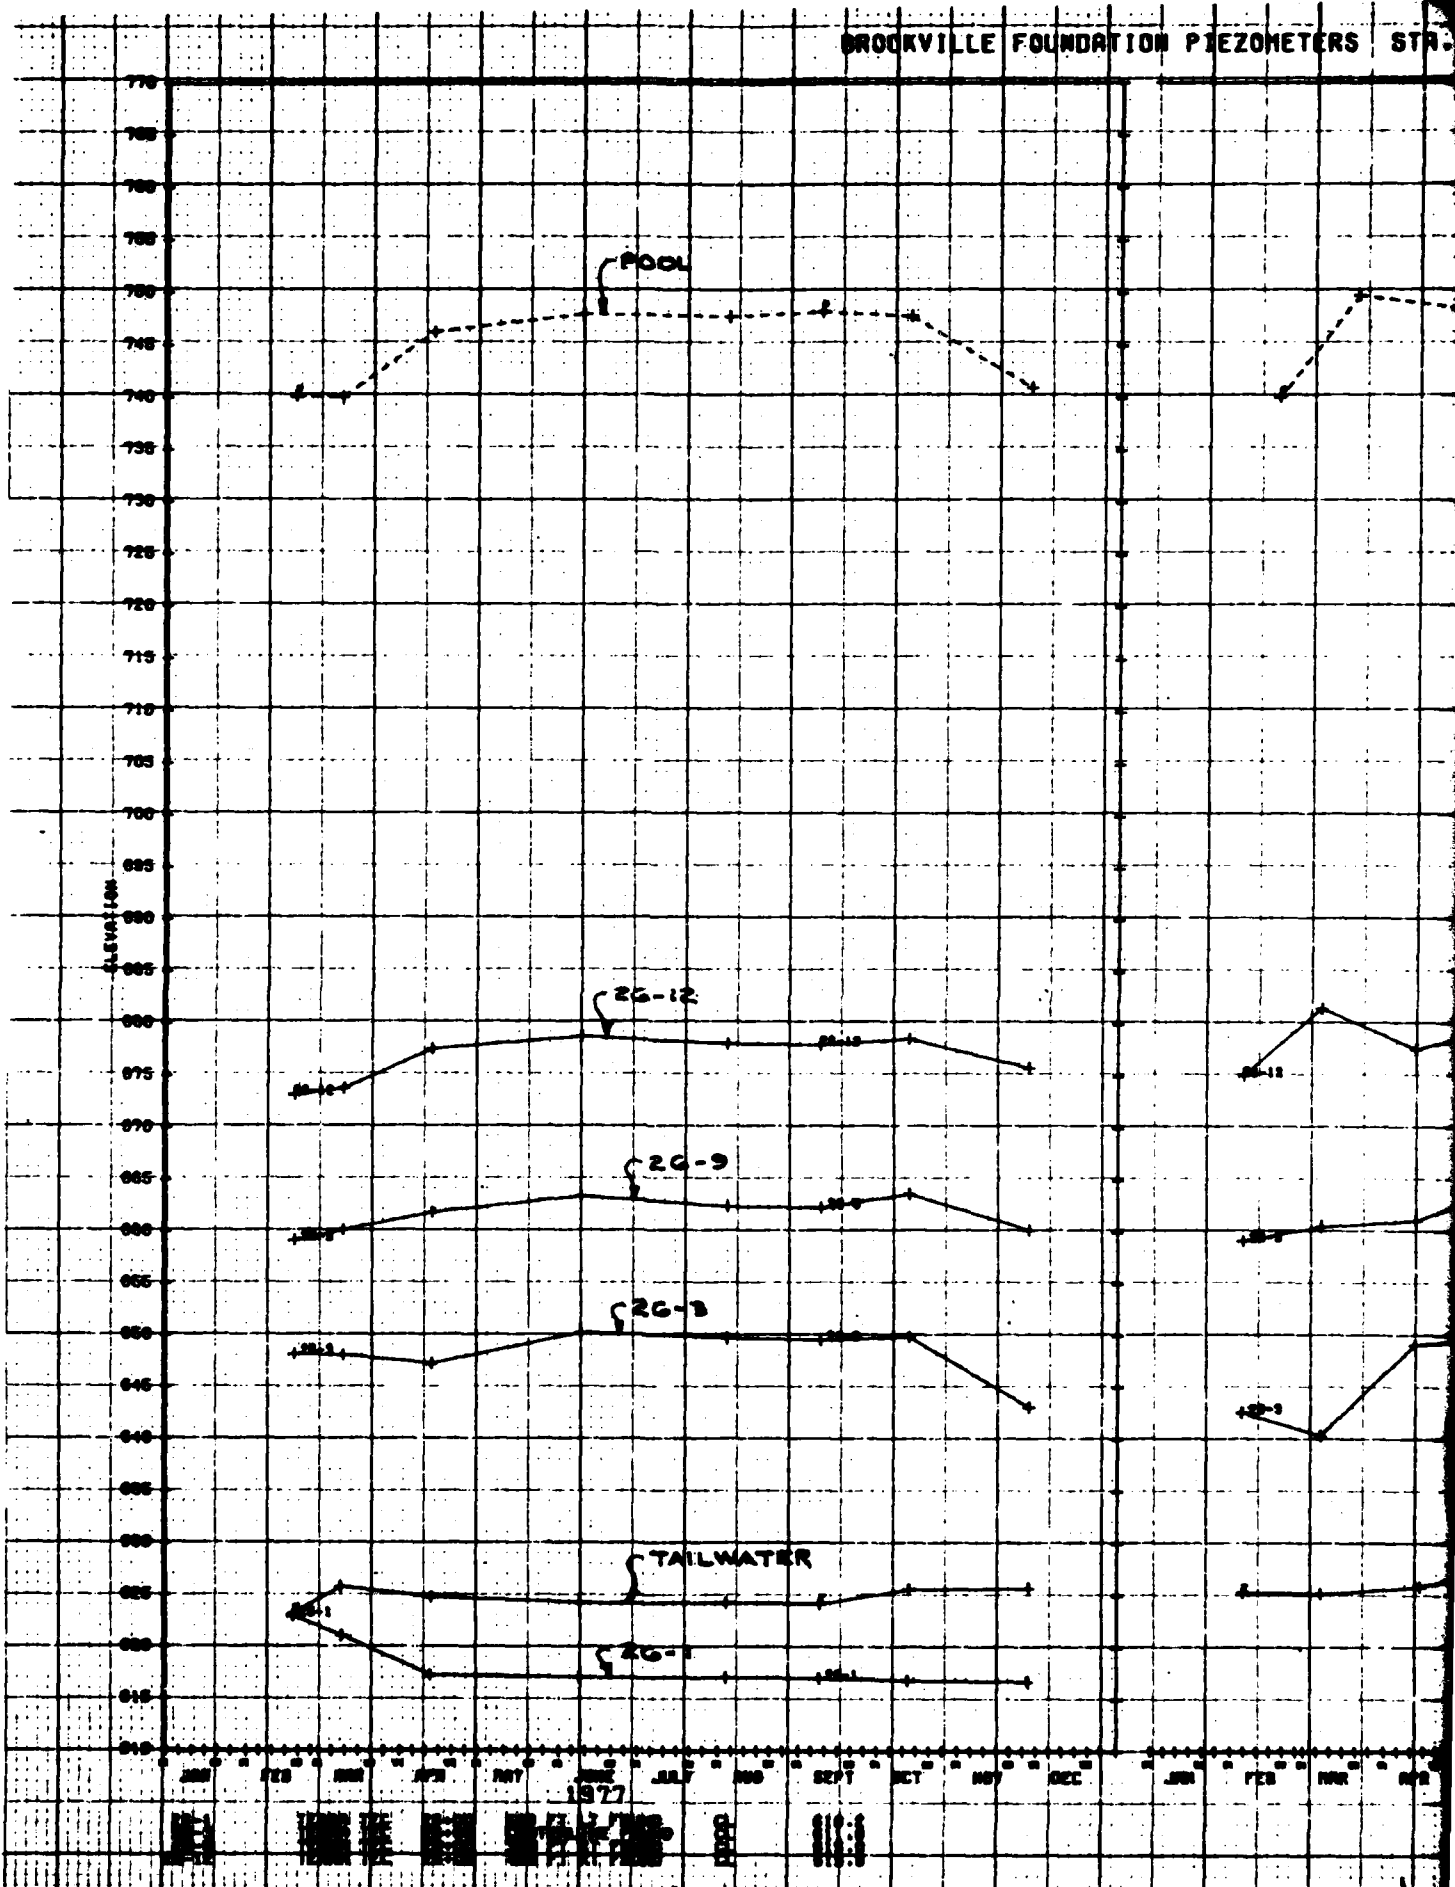
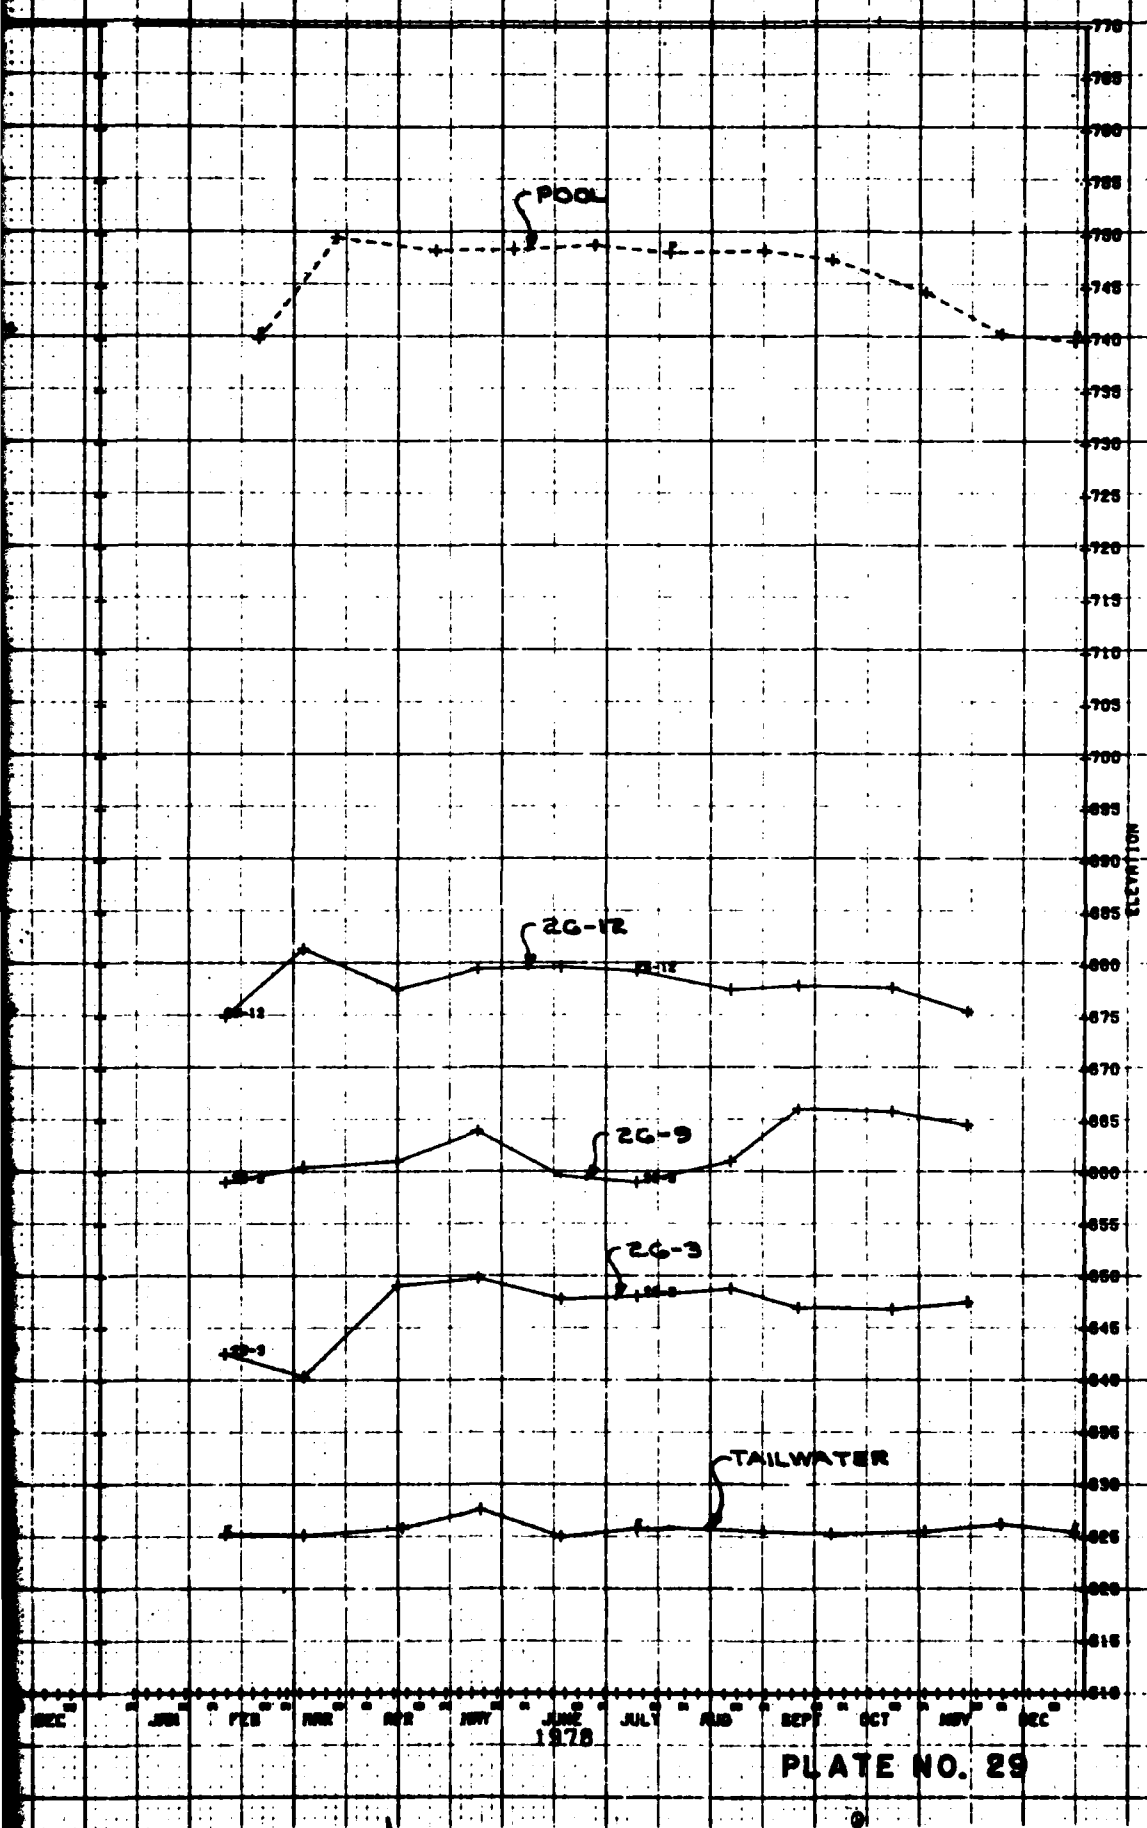
BROOKVILLE FOUNDATION PIEZOMETERS STA.

FOUNDATION PIEZOMETERS STR. 26+00

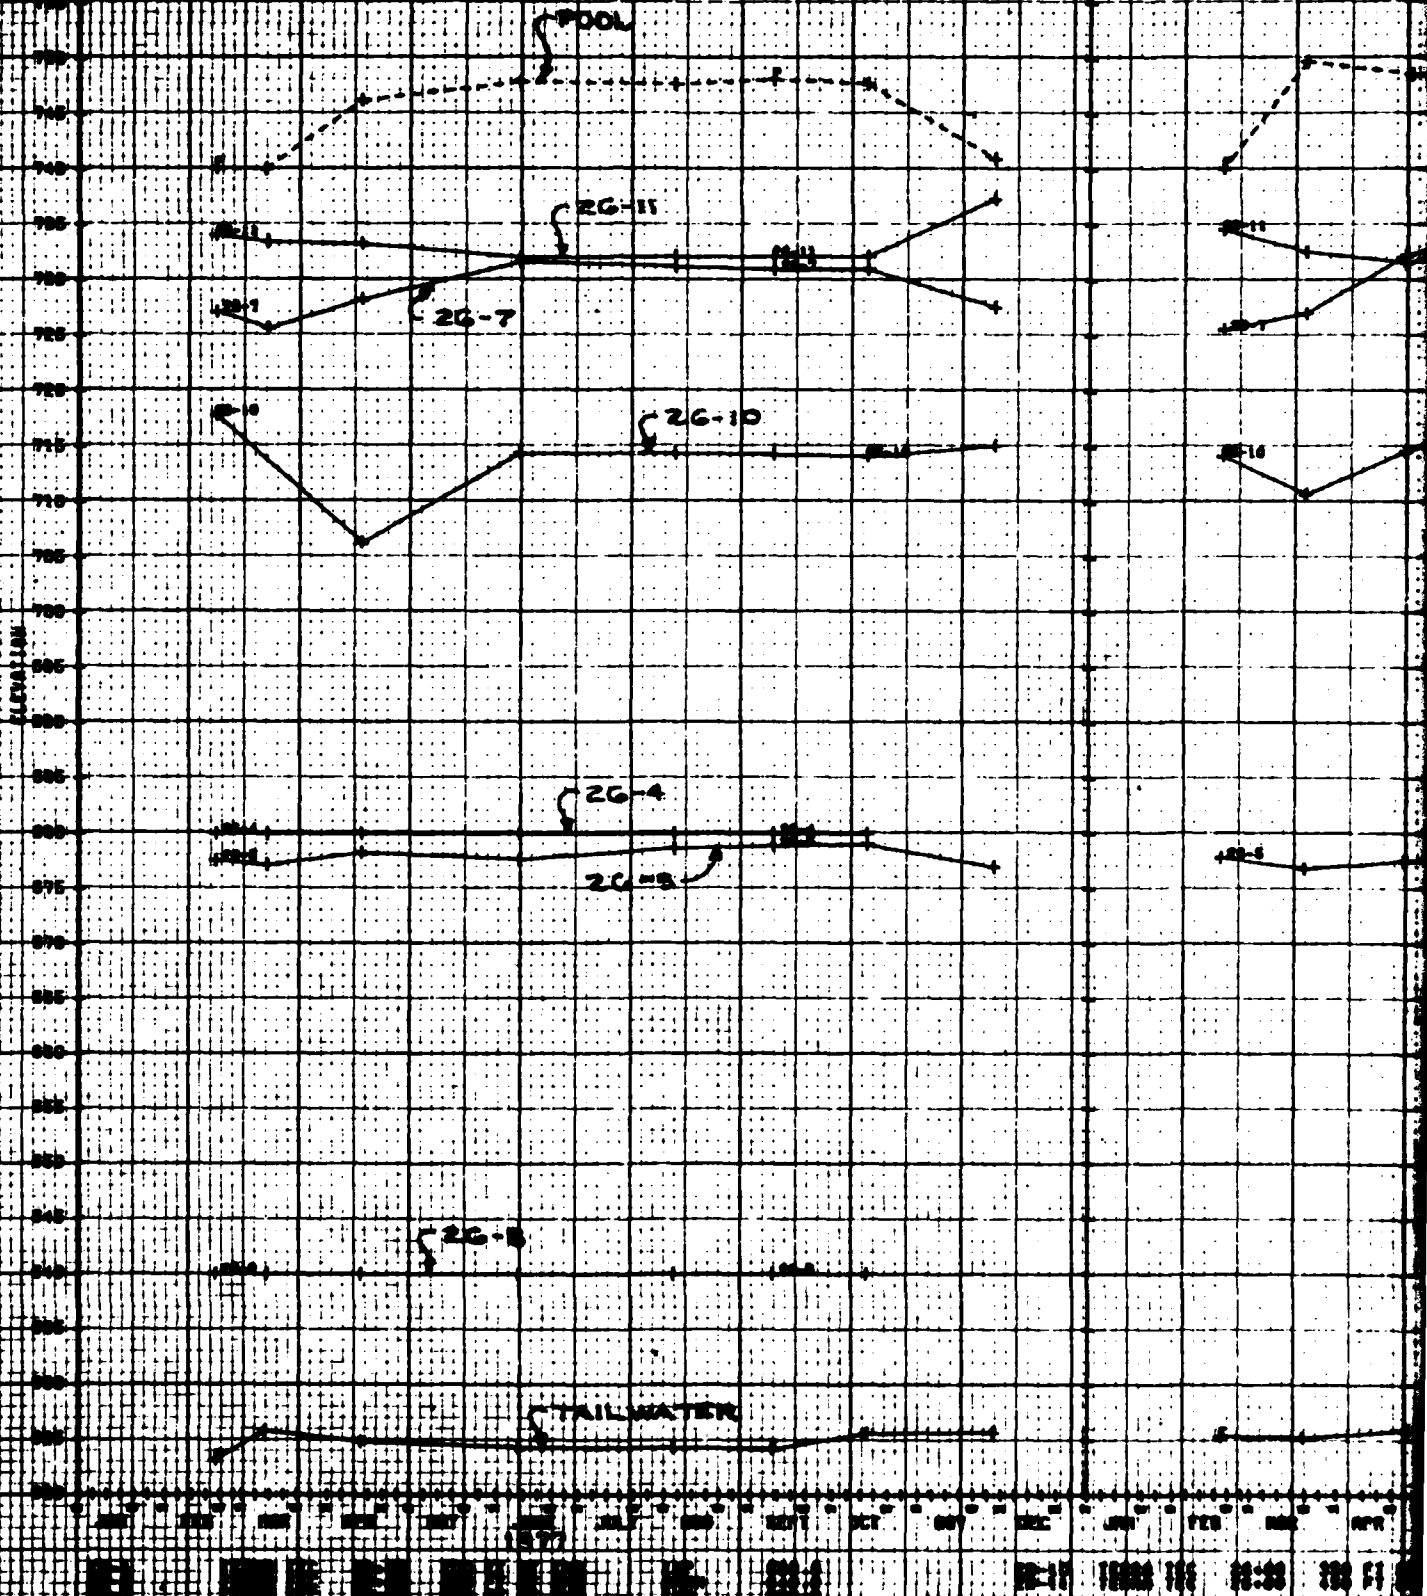
BROOKVILLE U. S. EMBANKMENT PIEZOMETERS

EMERGENT PIEZOMETERS STA. 26+00

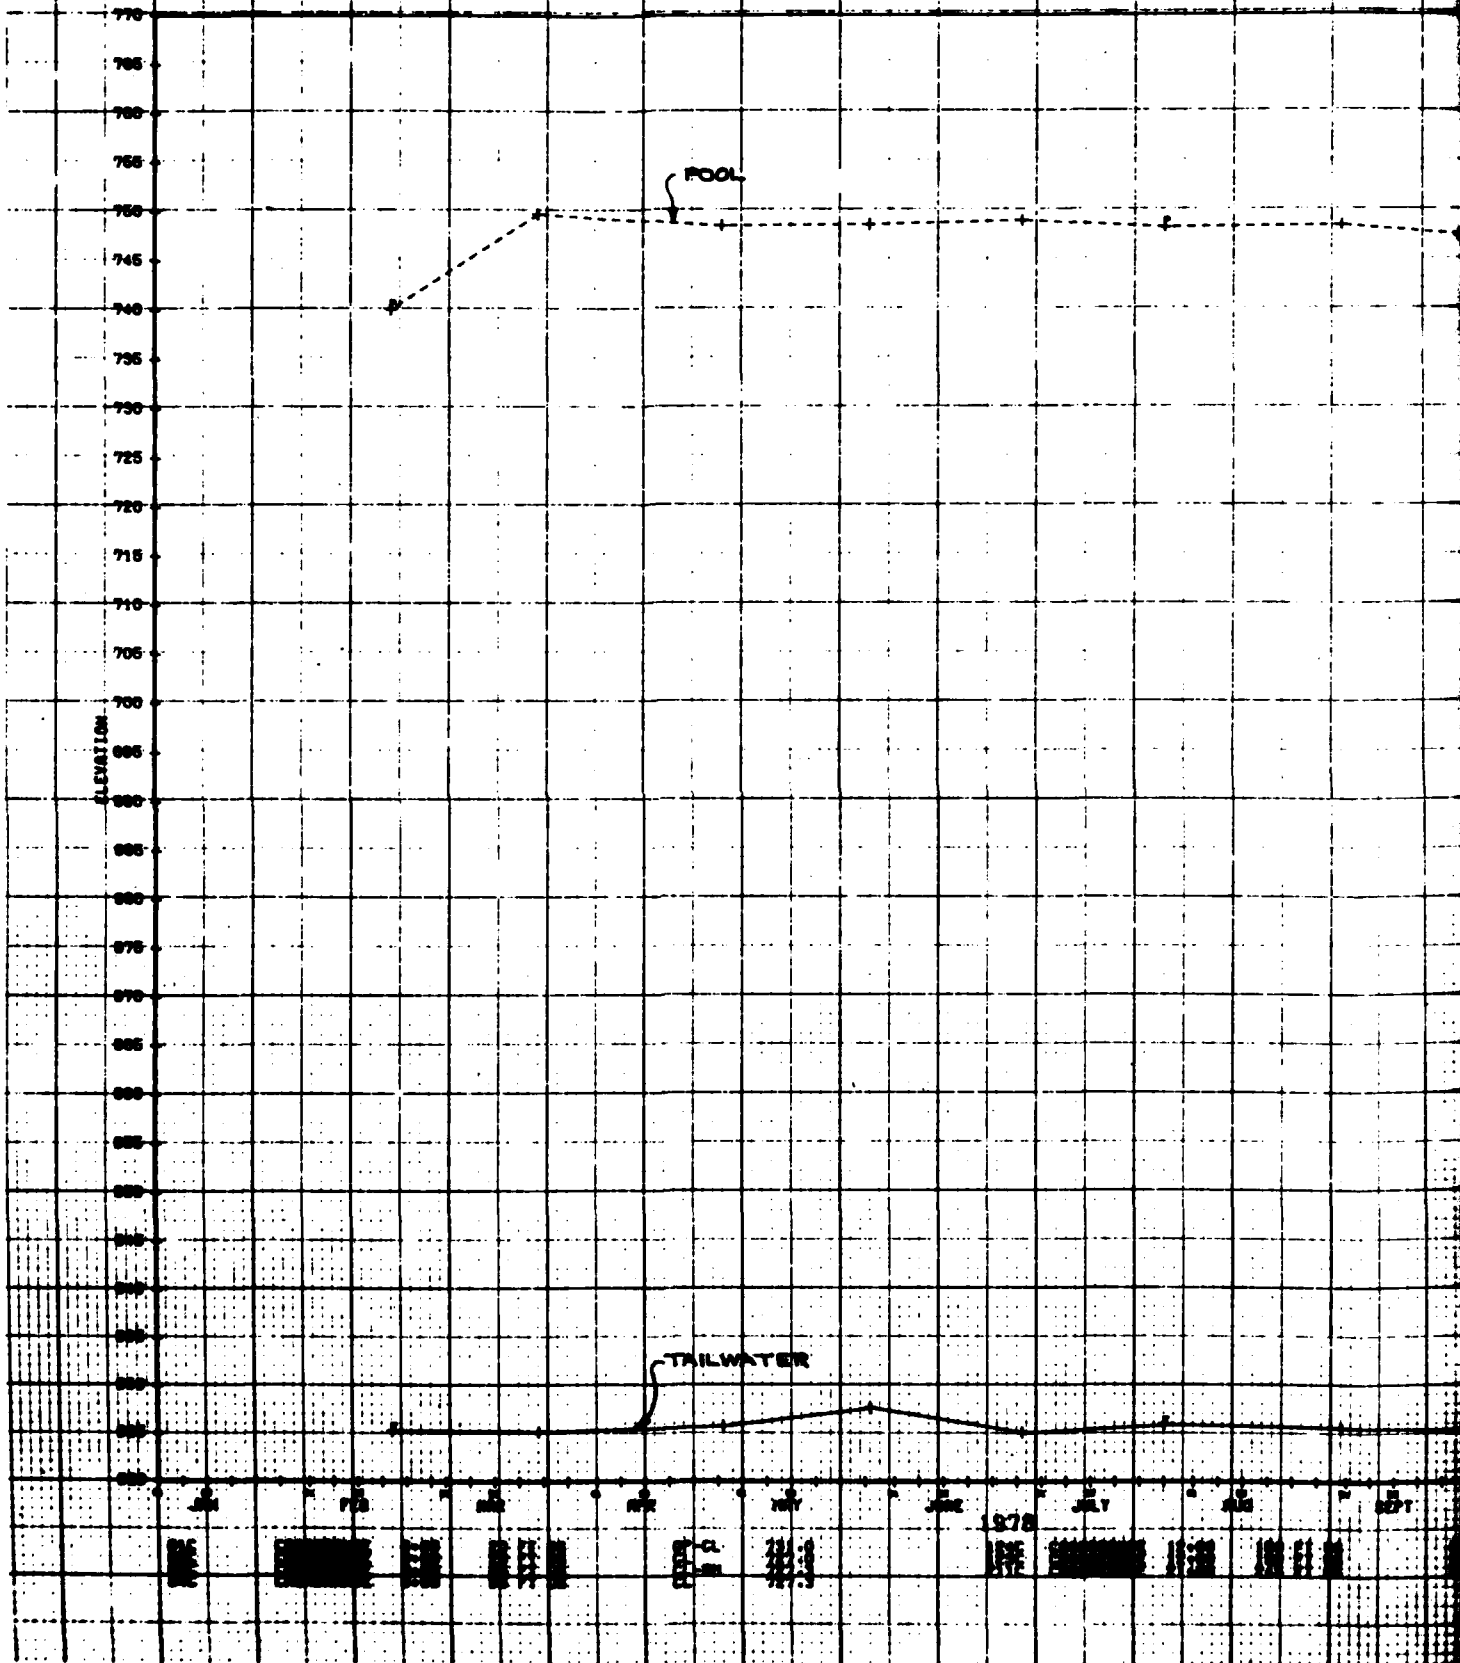
BROOKVILLE REPLACEMENT PIEZOMETERS CASAGRANDE

(1) General. Most of the closed system piezometers initially installed in the dam have become inoperative and, where possible, were recently replaced by Casagrande type piezometers. The following table summarizes the status of the closed system piezometers as of 1 July 1979.

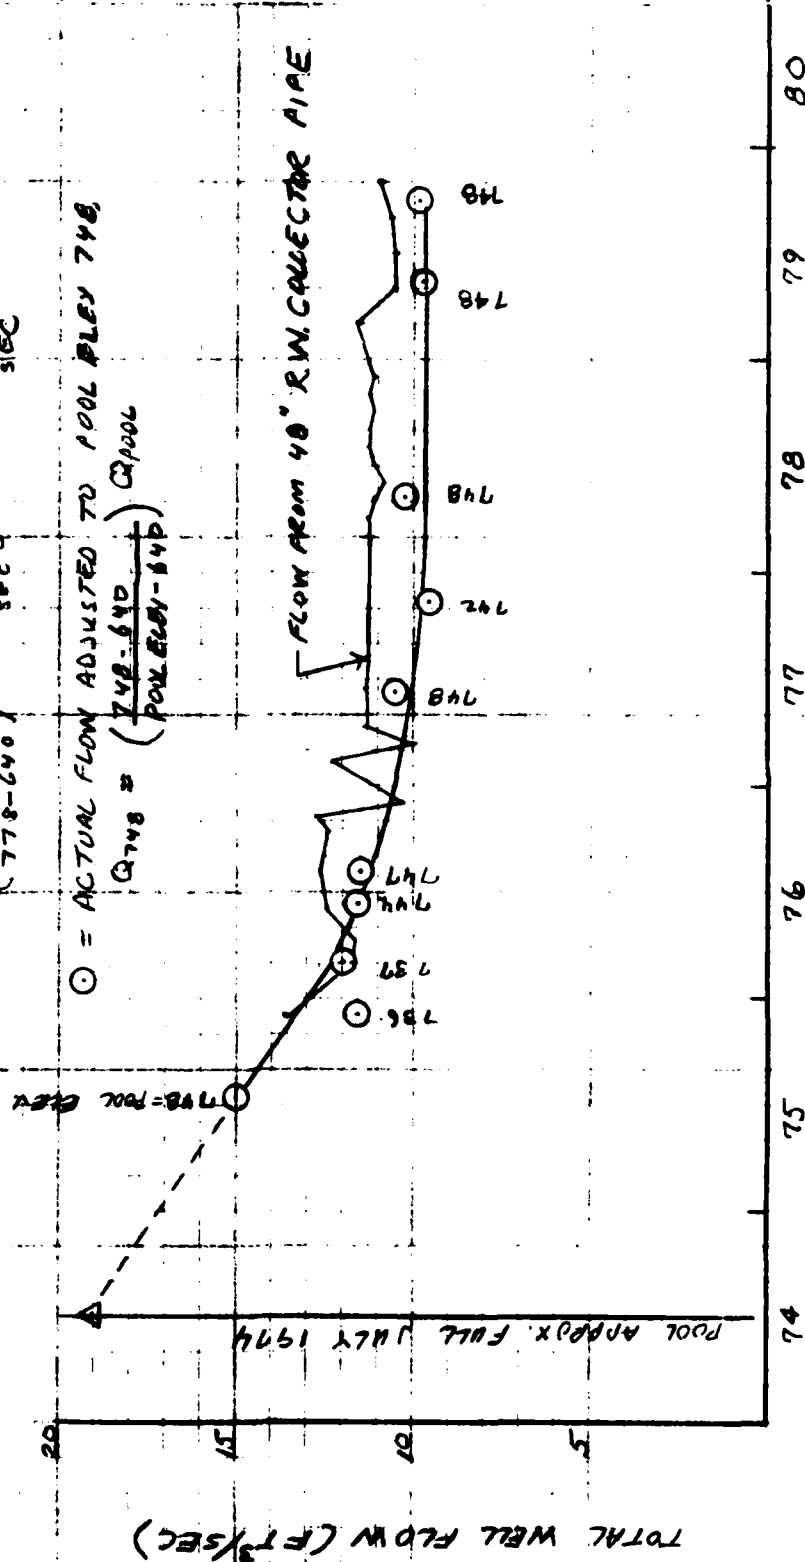
PLATE NO. 35

RELIEF WELL SOUNDINGS

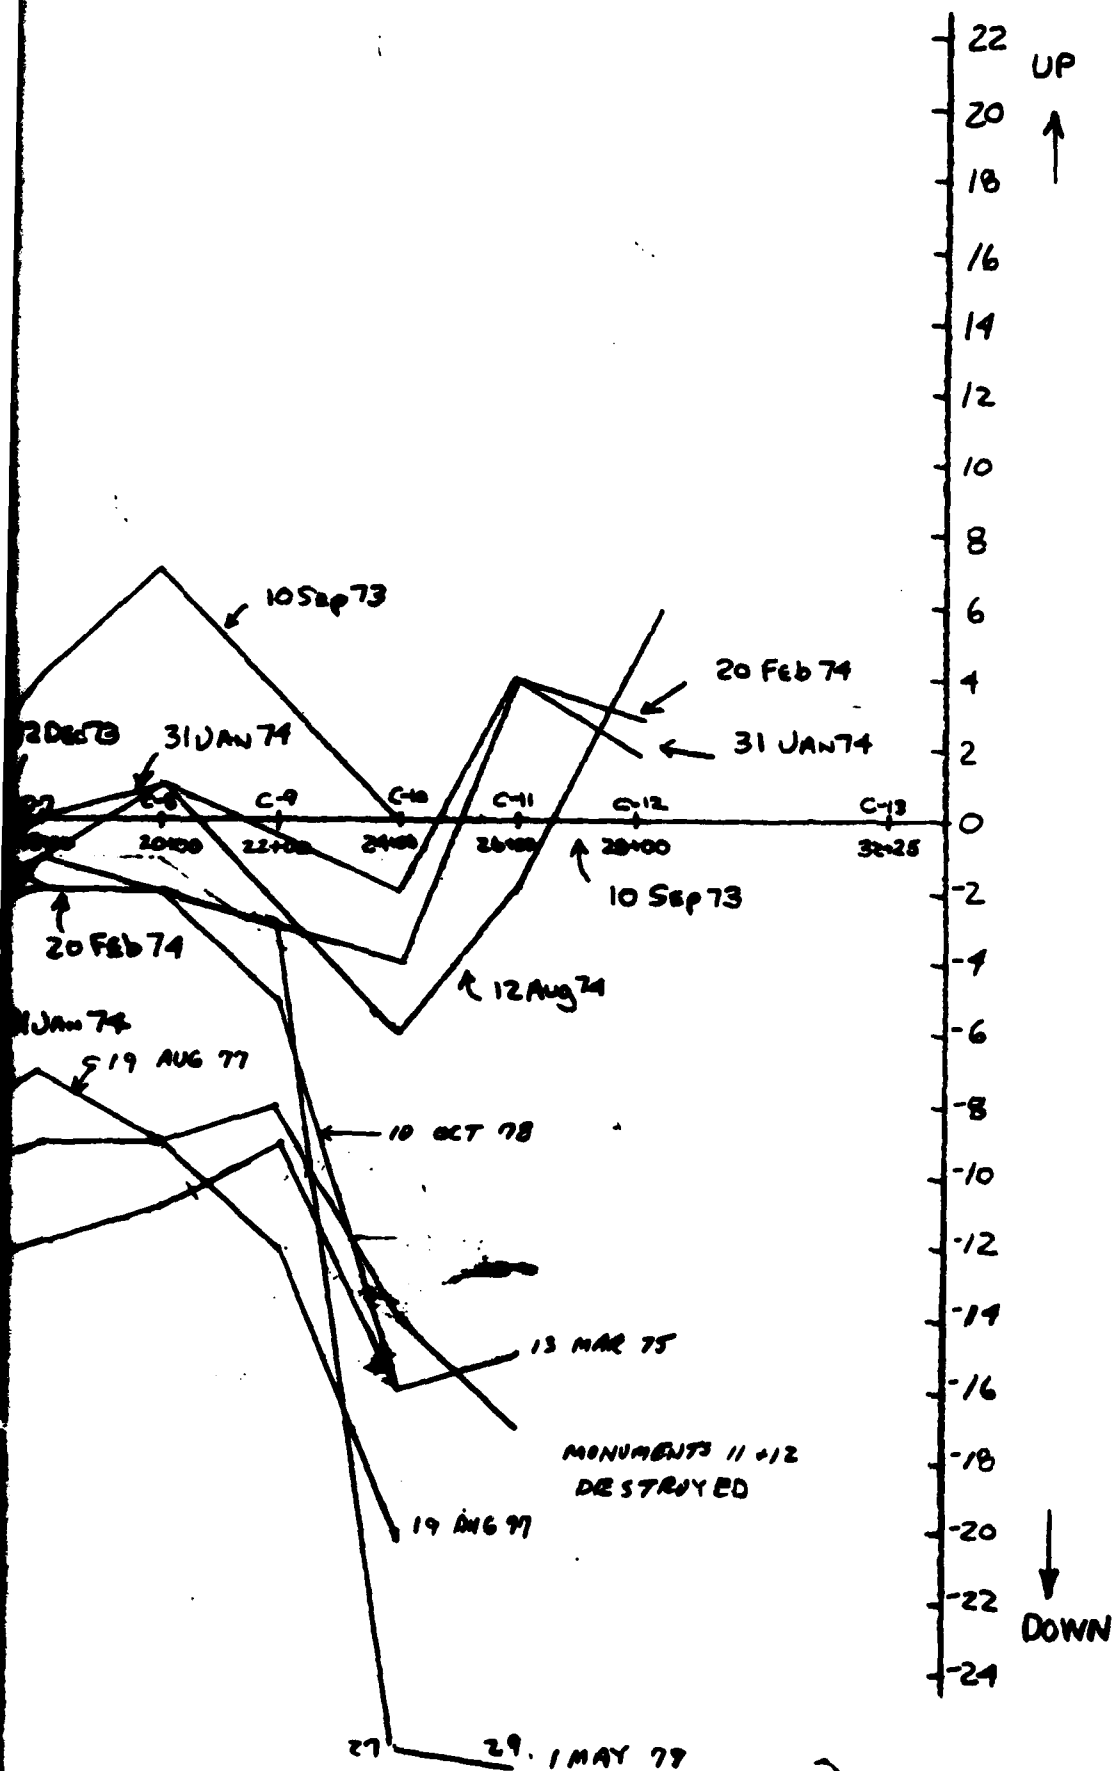
PLATE 37

27 July 73	
INITIAL READING	
MON. NO.	ELEV.
C-3	678.12
C-4	679.36
C-5	678.50
C-6	678.34
C-7	678.65
C-8	678.90
C-9	694.86
C-10	700.01
C-11	686.50
C-12	680.13
C-13	808.86

BROOKVILLE LAKE
MOVEMENT MONUMENTS
400' DOWNSTREAM &
VERTICAL MOVEMENT

VERTICAL CUMULATIVE MOVEMENT
(HUNDRETHS OF A FOOT)

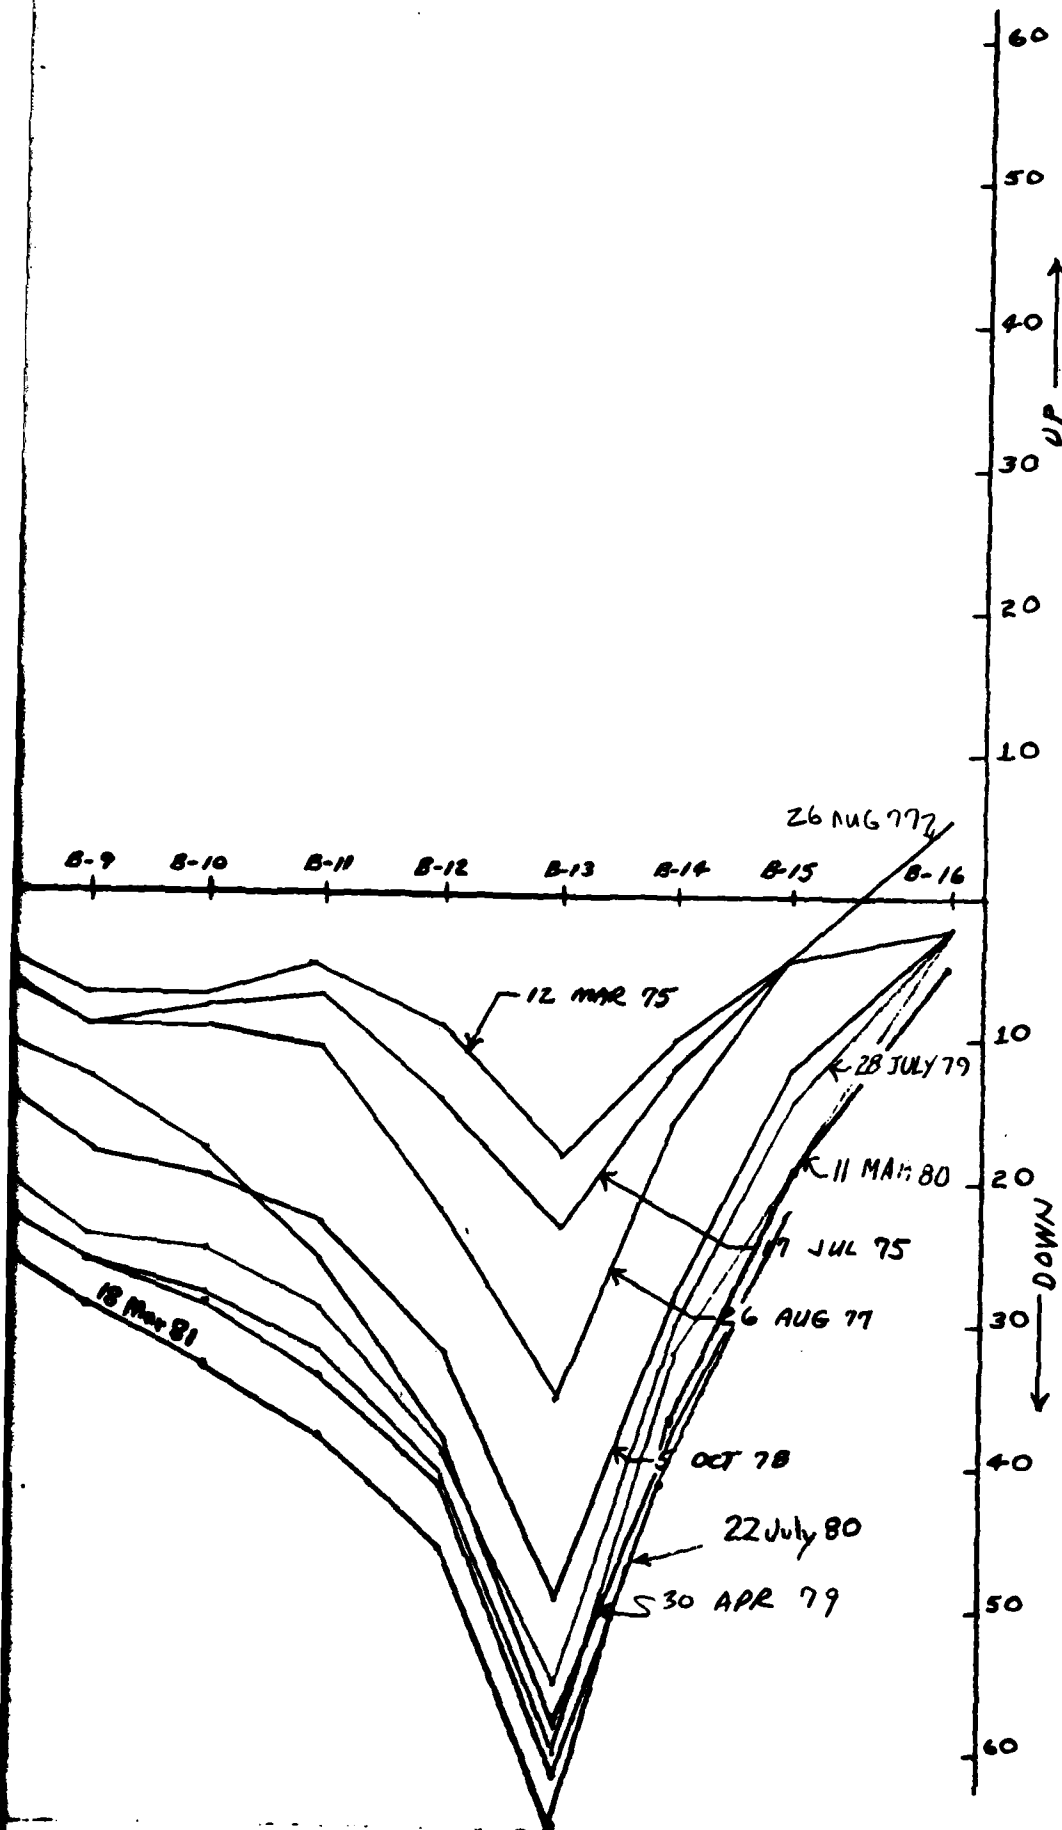
INITIAL READING 21 AUG 74	
MON	ELEV.
B-2	808.80
B-3	808.79
B-4	809.26
B-5	809.78
B-6	809.67
B-7	809.63
B-8	809.87
B-9	809.73
B-10	809.92
B-11	809.82
B-12	809.49
B-13	809.80
B-14	809.60
B-15	808.56
B-16	810.71

BROOKVILLE LAKE
MOVEMENT MONUMENTS
B LINE 15' DS
VERTICAL MOVEMENT

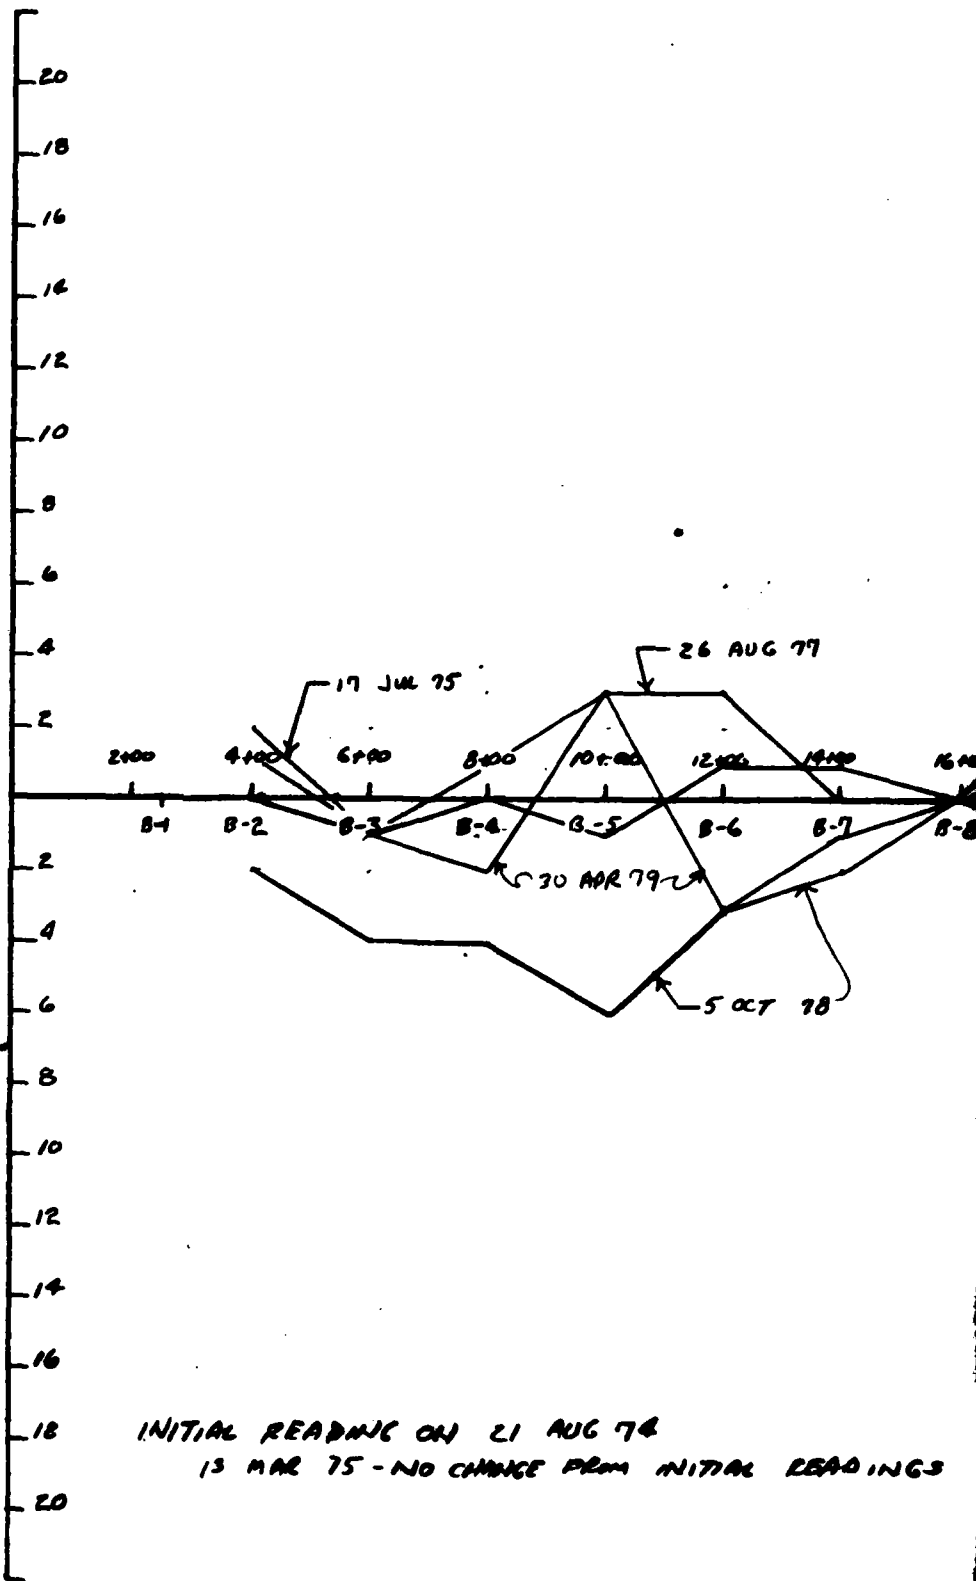
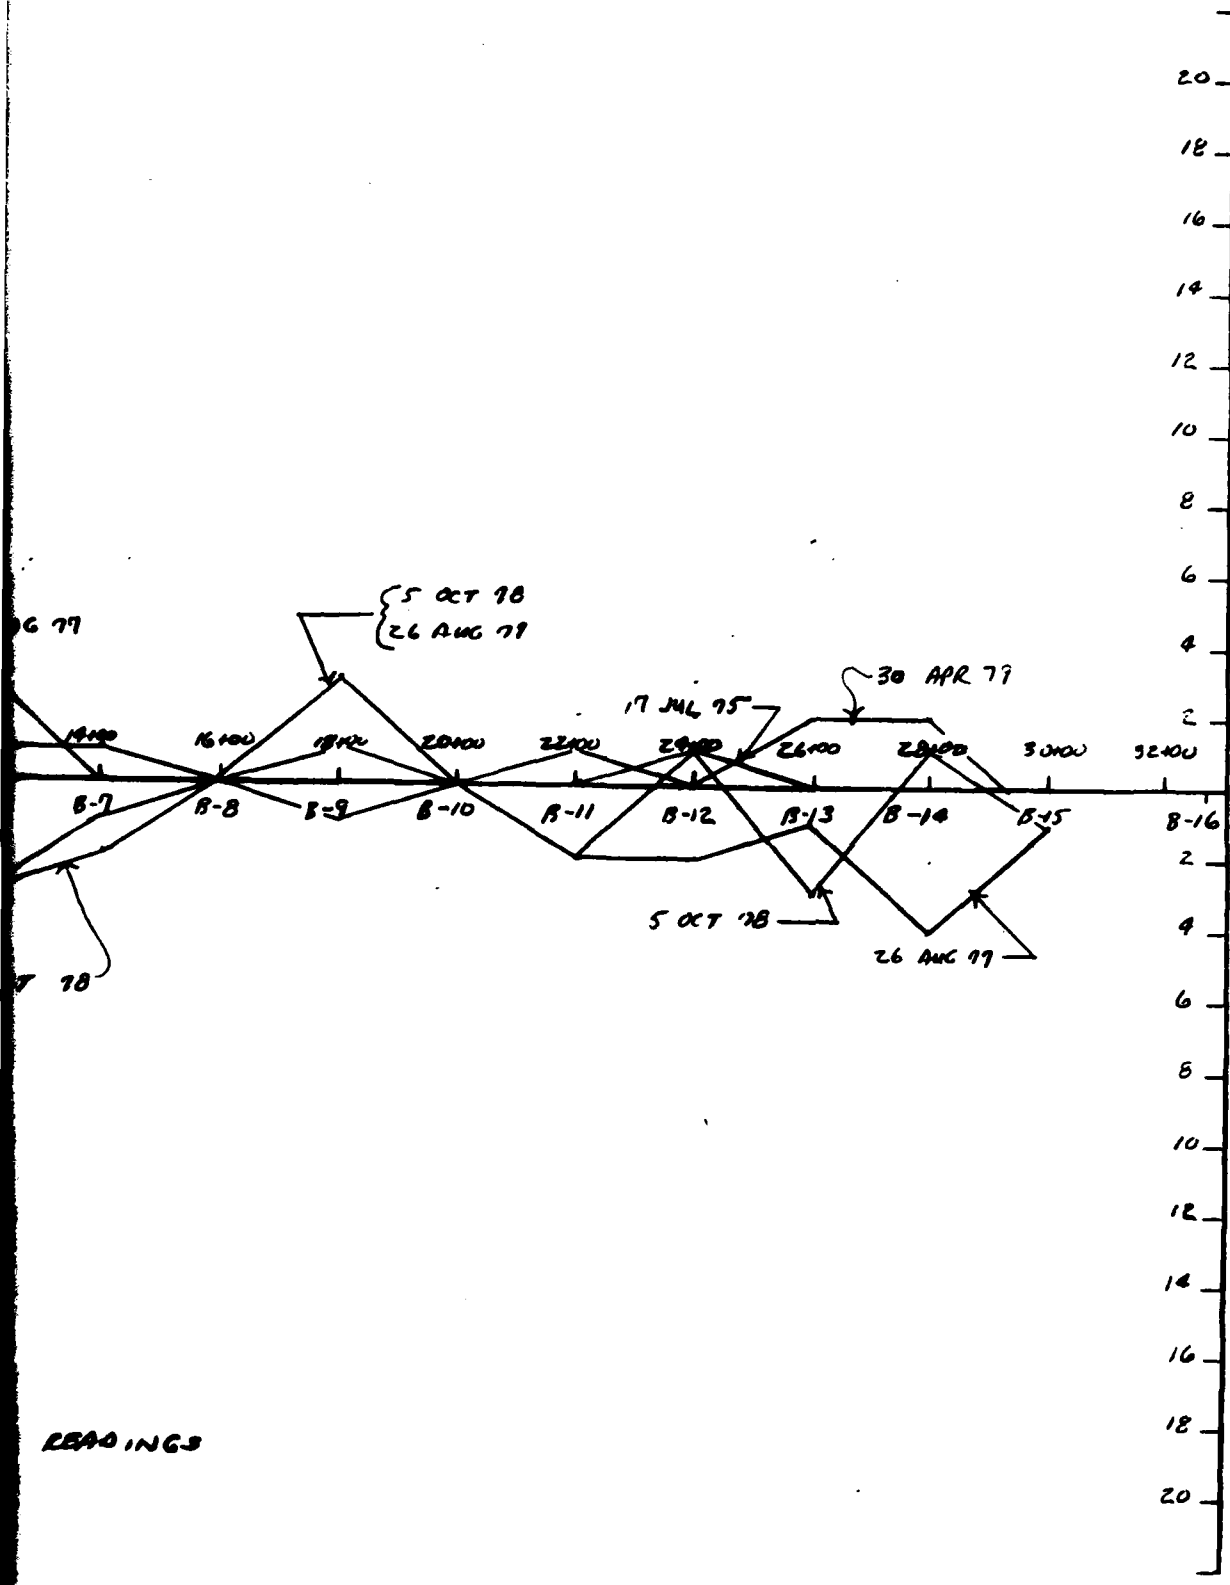
HORIZONTAL CUMULATIVE MOVEMENT (HUNDRETHS OF A FOOT)

INITIAL READING ON 21 AUG 74

13 MAR 75 - NO CHANGE FROM INITIAL READINGS

BROOKVILLE LA
MOVEMENT MONUM
15' DOWNSTREAM
HORIZONTAL MOVEMENT
